Name of Dam: Cove No. 2

Location: Frederick County, State of Virginia

Inventory Number: VA 06911

PHASE I INSPECTION REPORT NATIONAL DAM SAFETY PROGRAM

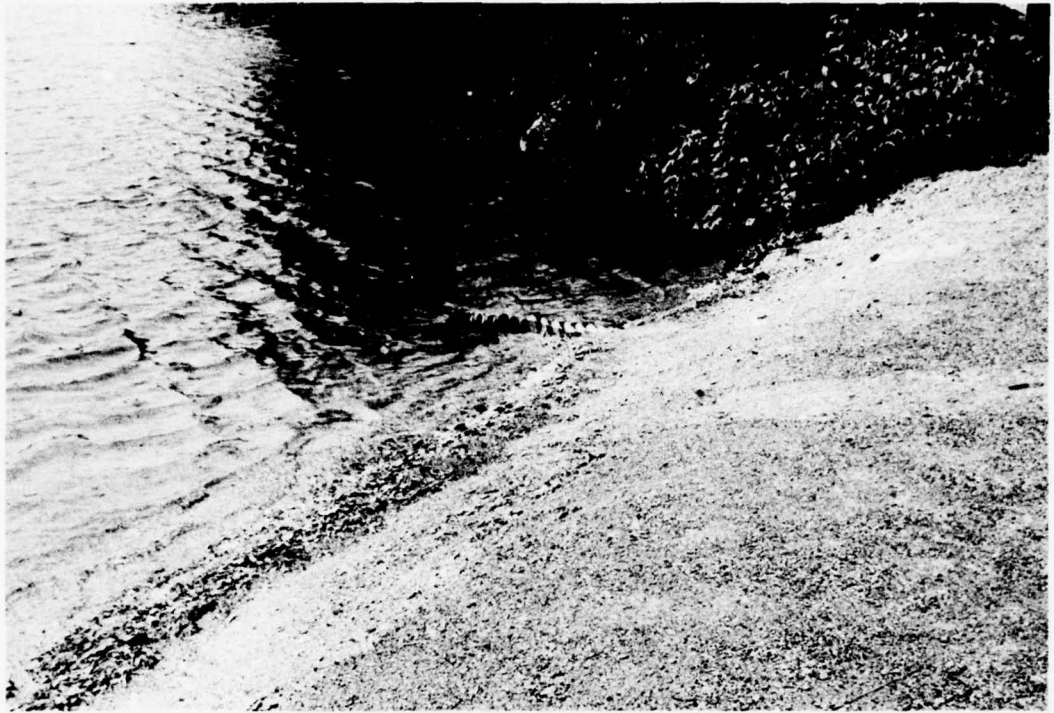
PHOTO 1

C. M. P. Intake of Principal Spillway at Left Abutment

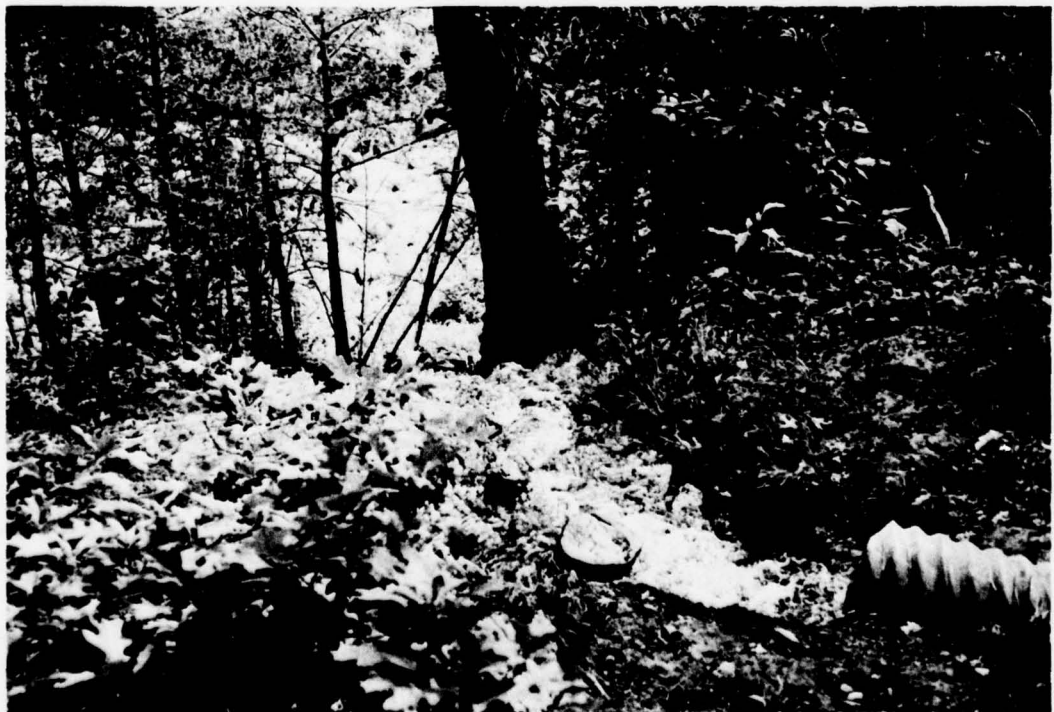
PHOTO 2

C. M. P. Outlet on Top of Ridge Near Left Abutment

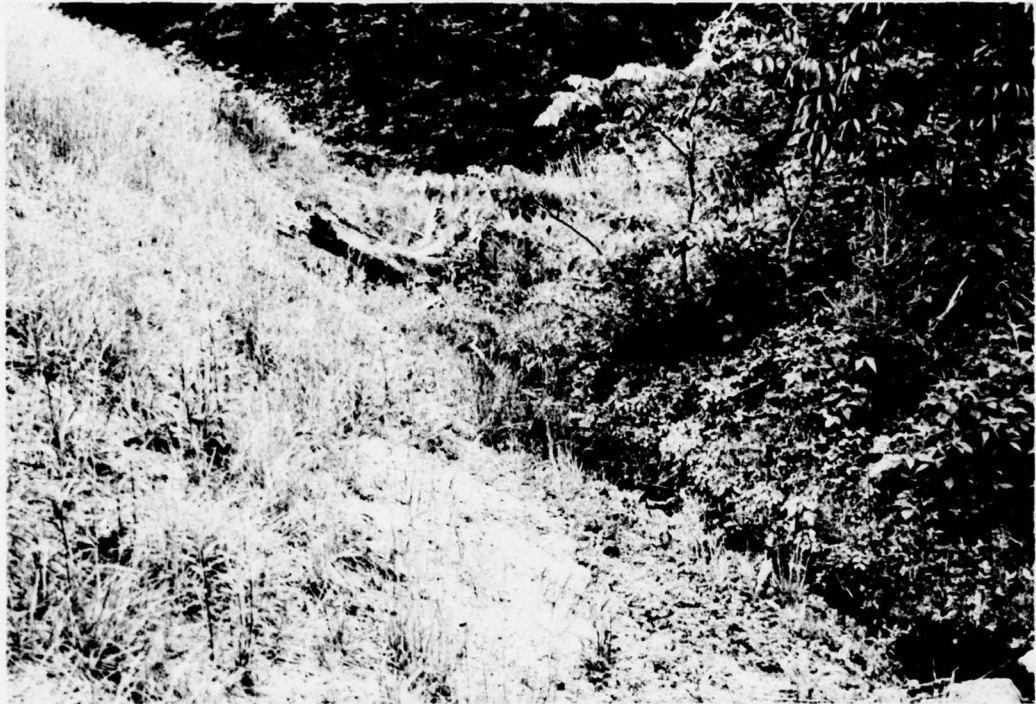
PHOTO 3

- Clear seepage was found all along the toe of the embankment with flows ranging from 0.5 g.p.m. to 3.0 g.p.m. Some of the seepage water is reddish-brown colored due to an iron precipitate. These clear seeps should be checked regularly for evidence of piping.

- 6.2.1 Visual Observations: There is no sloughing or slope failure in the embankment, cut slopes and drainage structures. Clear seepage was observed along the downstream toe of the slope ranging from 0.5 g.p.m. to 3.0 g.p.m. as measured at four locations (see Photo 3). Springs were reported in the shale foundation of the dam, during construction. The clear seepage from the shale fill at the toe of the dam does not appear to be eroding the embankment. The abutments have clear seepage upwelling near the downstream toe of the fill. Determination of the source of the clear seepage is desirable to properly evaluate embankment stability.

Streamflow Along Downstream Toe of Embankment

There is no need for emergency measures, but the clear seepage at the toe needs to be studied further by the installation of piezometers.

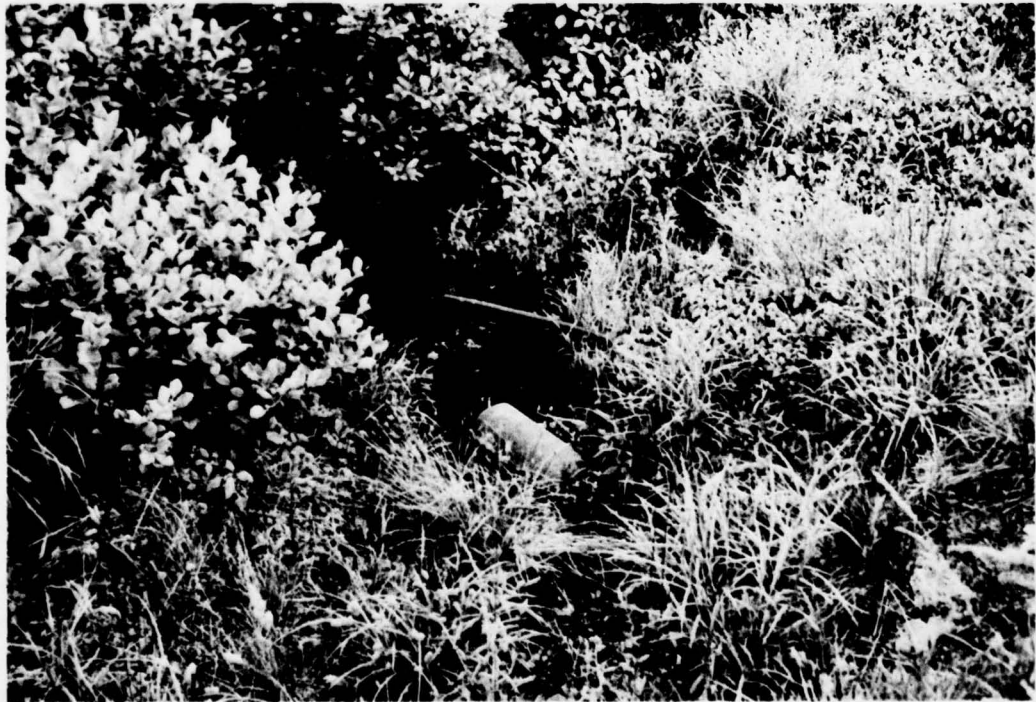
PHOTO 4

Outlet of 10 Inch Steel Pipe at Toe of Embankment

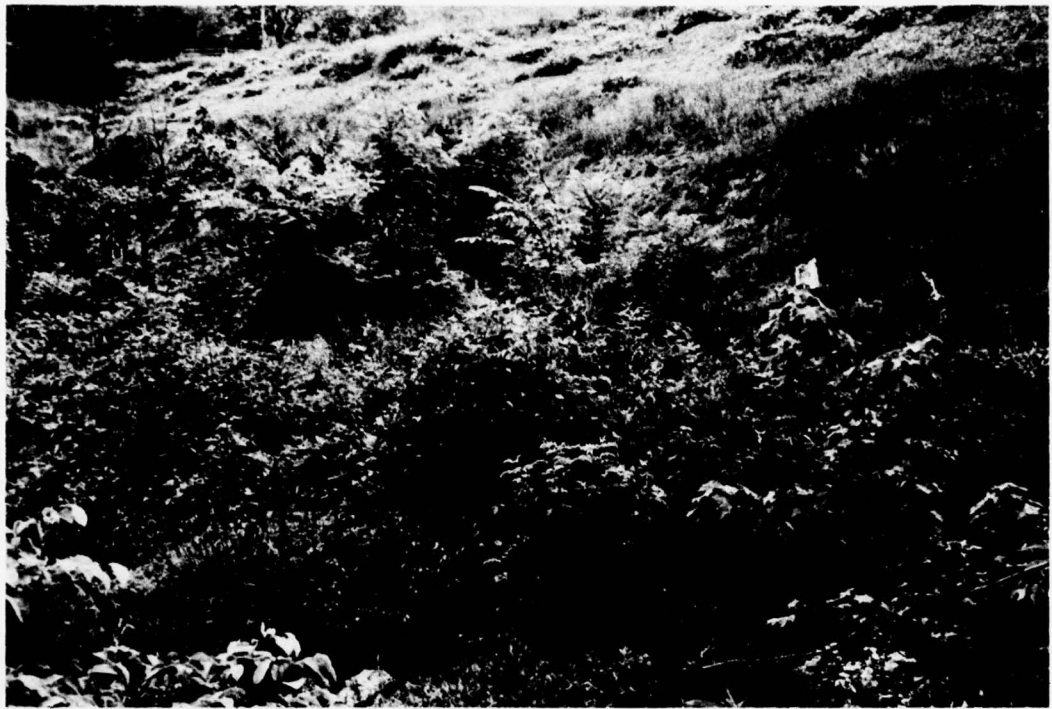
PHOTO 5

Downstream Slope of Dam Looking Toward Right Abutment
